**Flood Control Project Maintenance
Levee Inspections**

Maintenance Issue Types Only, Levee Inspection Report By Mile - Spring 2019

Levee District No. 0001 (Glenn County)

Waterway	Bank	Unit Miles	Inspection Start/End	Inspector
Unit No. 01 Sacramento River	Right	12.23	04/26/2019 04/26/2019	Makar Sokol

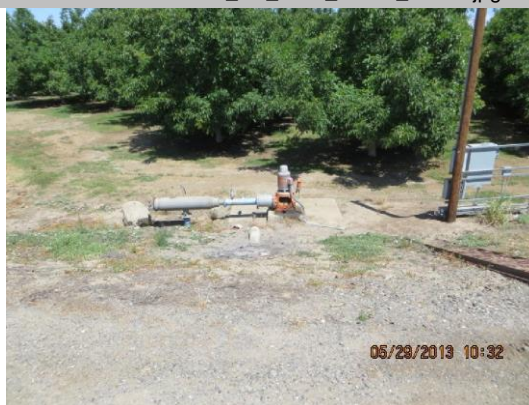
Photo 1 of 3 : UCIP_SP_2019_14332_23582.jpg

LM Start	2.22	Rating **	M	Issue No.	402
LM End	2.22	Issue Type +	Ma	Location *	
Category	Supplemental			GPS Latitude/Longitude	
				Start	End
Item	DWR UCIP LMA Responsibility			39.501690 °	39.501690 °
				-122.006099 °	-122.006099 °
DWR ID	22944				
Comment Code					
Inspector Comment					
FS_ID:14332 DS_ID:22944 EP_NO: N/A Repair Type: Non-Urgent Crossing Status: Found UCIP Comments: Appears abandoned and should be done so properly. FIELD_STRUCT_DESC: *ABANDONED* 8-inch drainage pipe of an unknown material sleeved through a 12-inch pipe of an unknown material through the levee, 9.5 feet below the crown. Flap gate located on the waterside (WS). Pipe open on the landside (LS). [Additional Reference(s): USACE Sacramento O&M Manual 140, May 1960, (HLM 2.27)]. FS Date: 5/29/2013

Pump at location of pipe on LS toe.

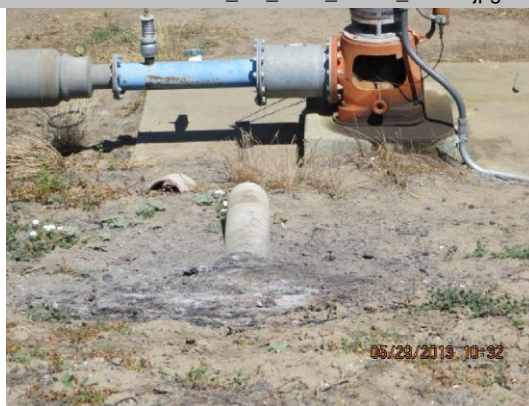
Photo 2 of 3 : UCIP_SP_2019_14332_23581.jpg

LM Start	2.22	Rating **	M	Issue No.	402 (cont)	
LM End	2.22	Issue Type +	Ma	Location *		
Category	Supplemental			GPS Latitude/Longitude		
				Start	End	
Item	DWR UCIP LMA Responsibility			39.501690 °	39.501690 °	
				-122.006099 °	-122.006099 °	
DWR ID	22944					
Comment Code						
Inspector Comment						
FS_ID:14332 DS_ID:22944 EP_NO: N/A Repair Type: Non-Urgent Crossing Status: Found UCIP Comments: Appears abandoned and should be done so properly. FIELD_STRUCT_DESC: *ABANDONED* 8-inch drainage pipe of an unknown material sleeved through a 12-inch pipe of an unknown material through the levee, 9.5 feet below the crown. Flap gate located on the waterside (WS). Pipe open on the landside (LS). [Additional Reference(s): USACE Sacramento O&M Manual 140, May 1960, (HLM 2.27)]. FS Date: 5/29/2013

Pipe next to pump at LS toe.

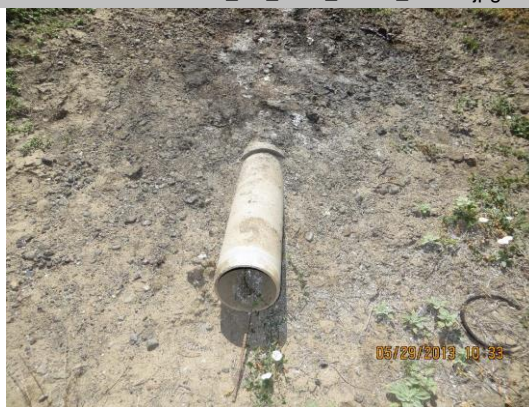
Photo 3 of 3 : UCIP_SP_2019_14332_23580.jpg

8-inch pipe sleeved through a 12-inch concrete pipe.

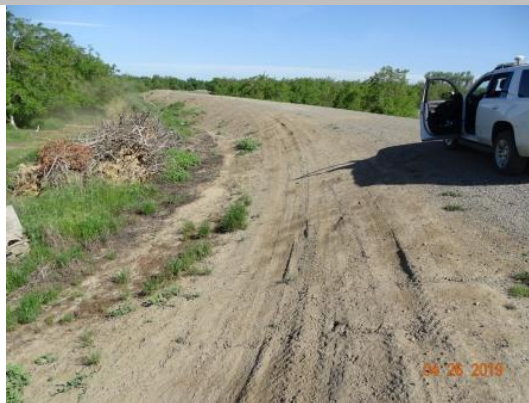
Photo 1 of 1 : SP_2019_LD0001G_432_77_20190429_00109.jpg

LM Start	3.04	Rating **	M	Issue No.	77
LM End	3.04	Issue Type +	Ma	Location *	LS
Category	Earthen Levee			GPS Latitude/Longitude	
				Start	End
Item	Slope Stability			39.512932 °	39.512932 °
				-122.009074 °	-122.009074 °
DWR ID	DWR_LD0001G_01_s_2019_77				
Comment Code					
S3 : Repair the levee slope damaged by vehicle traffic and prevent access where possible.					
Inspector Comment

View of the landside slope damaged by vehicle traffic. Spring 2019.

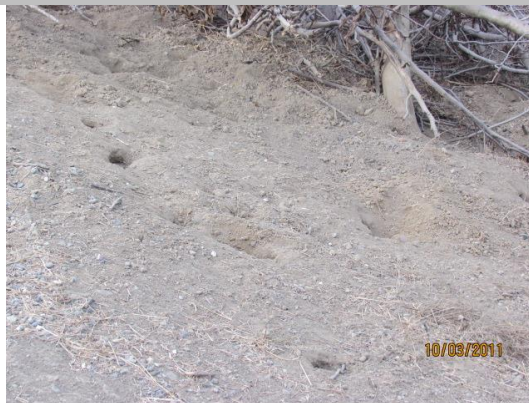
Photo 1 of 1 : SP_2019_LD0001G_432_395_20190313_00035.jpg

View of the rodent holes along the LS toe.

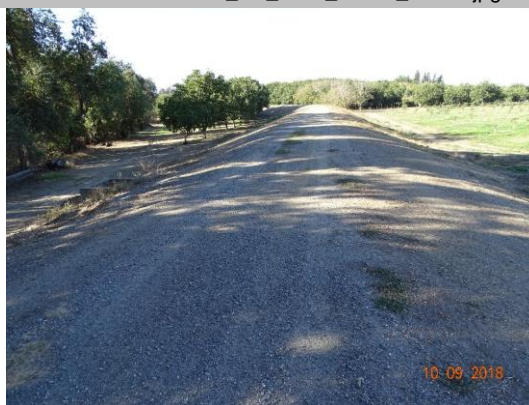
Photo 1 of 3 : UCIP_SP_2019_53006_78123.jpg

Comment Code					
Inspector Comment					
FS_ID:53006 DS_ID:22904 EP_NO: 9572 Repair Type: Urgent Crossing Status: Found UCIP Comments: 10/9/2018 No change to the crossing status. Flap gate on WS cannot be fully closed due to a 3-inch pipe through drainage pipe crossing the levee. Water is supplied from a well on LS via 3-inch pipe to the WS for irrigation/drinking purposes. Owner will need to remove obstruction to allow proper flap gate closure. (O.Yakimov - DWR)12/21/2016 Flap gate on WS does not appear to be broken however, flap gate does not fully close due to a 3-inch aluminum pipe sleeve through larger pipe. Need to remove 3-inch pipe in order to have WS flap gate close and to be compliant with Title 23. (O. Magana - DWR UCIP)05/29/2013 Broken flap gate and Concrete headwall on LS toe possibly tilting. Also a 3-inch alluminum irrigation line through the pipe. (W. Wylie - DWR UCIP) FIELD_STRUCT_DESC: 18-inch steel drainage pipe through the levee, 7.3 feet below the crown. Flap gate in 6-inch by 6-inch concrete box located on the waterside (WS) end. Concrete headwall located on the landside (LS) toe. (18-inch pipe [HLM 4.05] authorized under Automatic Board Order (ABO) issued as Permit No. 9572, 1974 - Henry and Annabel B. Smith). [Additional Reference(s): DWR Levee Log, 1992. USACE Sacramento O&M Manual 140, May 1960, (HLM 4.05)]. FS Date: 10/9/2018 3:27:06 PM

View of levee crown at the crossing.

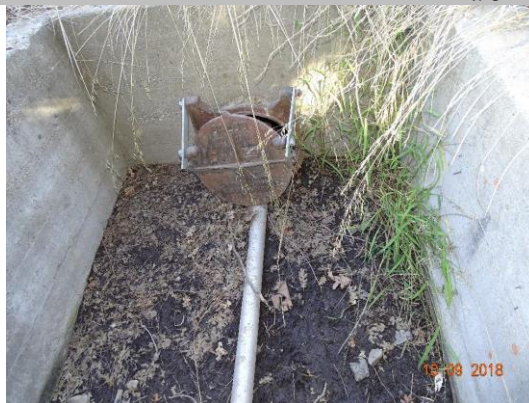
Photo 2 of 3 : UCIP_SP_2019_53006_78124.jpg

Comment Code						
Inspector Comment						
FS_ID:53006 DS_ID:22904 EP_NO: 9572 Repair Type: Urgent Crossing Status: Found UCIP Comments: 10/9/2018 No change to the crossing status. Flap gate on WS cannot be fully closed due to a 3-inch pipe through drainage pipe crossing the levee. Water is supplied from a well on LS via 3-inch pipe to the WS for irrigation/drinking purposes. Owner will need to remove obstruction to allow proper flap gate closure. (O.Yakimov - DWR)12/21/2016 Flap gate on WS does not appear to be broken however, flap gate does not fully close due to a 3-inch aluminum pipe sleeve through larger pipe. Need to remove 3-inch pipe in order to have WS flap gate close and to be compliant with Title 23. (O. Magana - DWR UCIP)05/29/2013 Broken flap gate and Concrete headwall on LS toe possibly tilting. Also a 3-inch alluminum irrigation line through the pipe. (W. Wylie - DWR UCIP) FIELD_STRUCT_DESC: 18-inch steel drainage pipe through the levee, 7.3 feet below the crown. Flap gate in 6-inch by 6-inch concrete box located on the waterside (WS) end. Concrete headwall located on the landside (LS) toe. (18-inch pipe [HLM 4.05] authorized under Automatic Board Order (ABO) issued as Permit No. 9572, 1974 - Henry and Annabel B. Smith). [Additional Reference(s): DWR Levee Log, 1992. USACE Sacramento O&M Manual 140, May 1960, (HLM 4.05)]. FS Date: 10/9/2018 3:27:06 PM

3-inch pipe obstructs flap gate from complete closing.

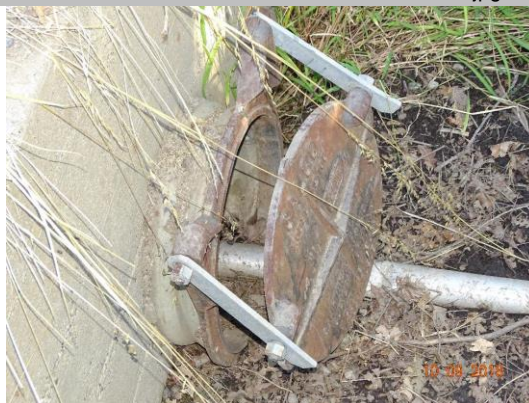
Photo 3 of 3 : UCIP_SP_2019_53006_78125.jpg

3-inch pipe obstructs flap gate from complete closing.

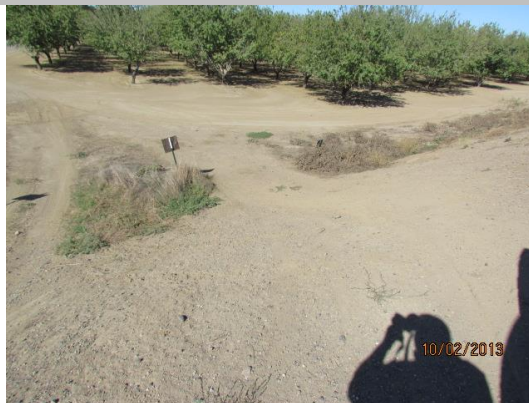
Photo 1 of 1 : SP_2019_LD0001G_432_57_20190313_00019.jpg

LM Start	5.06	Rating **	M	Issue No.	57
LM End	5.06	Issue Type +	Ma	Location *	LS
Category	Earthen Levee			GPS Latitude/Longitude	
				Start	End
Item	Slope Stability			39.534593 °	39.534593 °
				-121.995950 °	-121.995950 °
DWR ID	DWR_LD0001G_01_f _ 2013_57				
Comment Code					
S3 : Repair the levee slope damaged by vehicle traffic and prevent access where possible.					
Inspector Comment

View of the vehicle erosion along the slope of the levee.

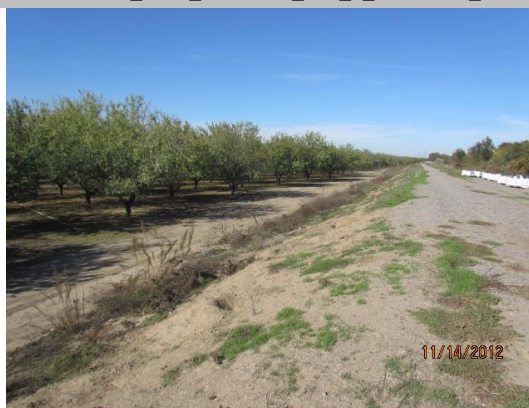
Photo 1 of 1 : SP_2019_LD0001G_432_7_20190313_00003.jpg

LM Start	5.08	Rating **	U	Issue No.	7
LM End	5.17	Issue Type +	Ma	Location *	LS
Category	Earthen Levee			GPS Latitude/Longitude	
				Start	End
Item	Animal Control			39.534741 °	39.536013 °
				-121.996024 °	-121.996702 °
DWR ID	DWR_LD0001G_01_f_2012_7				
Comment Code					
A3 : No rodents visible, but rodent burrows visible; need to backfill and compact or grout burrows.					
Inspector Comment

View of the rodent hole along the levee slope.

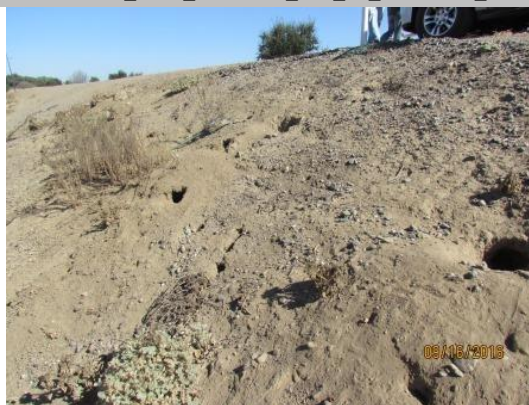
Photo 1 of 1 : SP_2019_LD0001G_432_67_20190313_00025.jpg

LM Start	5.22	Rating **	U	Issue No.	67
LM End	5.22	Issue Type +	Ma	Location *	LS
Category	Earthen Levee			GPS Latitude/Longitude	
				Start	End
Item	Animal Control			39.536750 °	39.536750 °
				-121.997090 °	-121.997090 °
DWR ID	DWR_LD0001G_01_s_2016_67				
Comment Code					
A3 : No rodents visible, but rodent burrows visible; need to backfill and compact or grout burrows.					
Inspector Comment

View of the rodent holes along the landside slope.

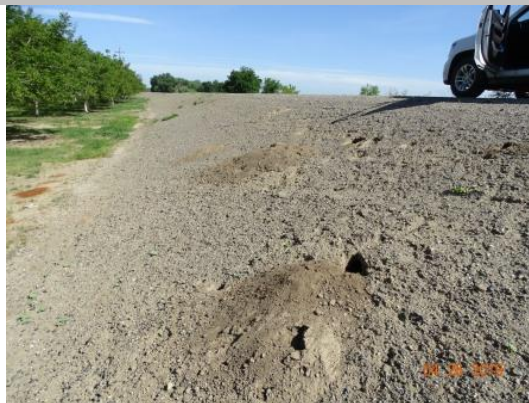
Photo 1 of 1 : SP_2019_LD0001G_432_82_20190429_00110.jpg

View of the rodent activity on the landside slope. Spring 2019.

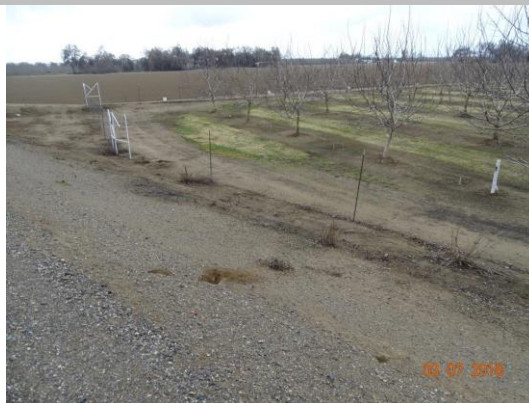
Photo 1 of 1 : SP_2019_LD0001G_432_70_20190313_00029.jpg

View of the rodent holes along the landside slope.

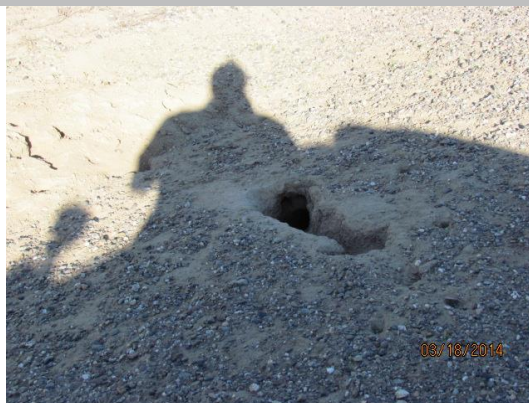
Photo 1 of 1 : SP_2019_LD0001G_432_47_20190313_00014.jpg

View of the rodent activity along the LS slope.

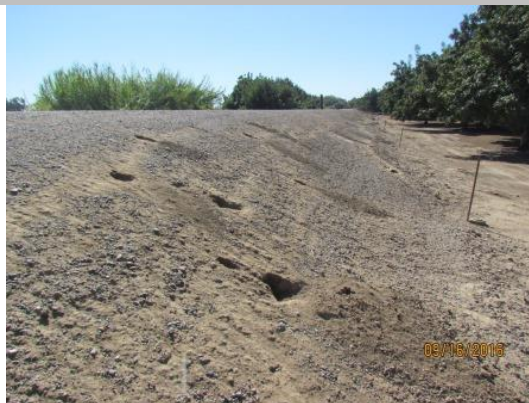
Photo 1 of 1 : SP_2019_LD0001G_432_76_20190313_00031.jpg

LM Start	6.24	Rating **	M	Issue No.	76
LM End	6.24	Issue Type +	Ma	Location *	LS
Category	Earthen Levee			GPS Latitude/Longitude	
				Start	End
Item	Animal Control			39.550725 °	39.550725 °
				-122.002370 °	-122.002370 °
DWR ID	DWR_LD0001G_01_f_2016_76				
Comment Code					
A3 : No rodents visible, but rodent burrows visible; need to backfill and compact or grout burrows.					
Inspector Comment

View of the rodent holes along the landside slope.

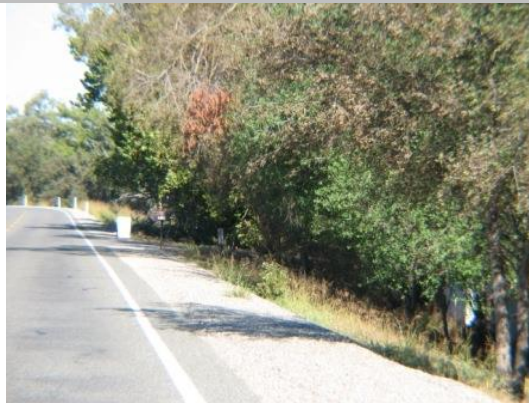
Photo 1 of 1 : SP_2019_LD0001G_432_20_20190313_00008.jpg

View of the trees and vegetation along the waterside slope of the levee.

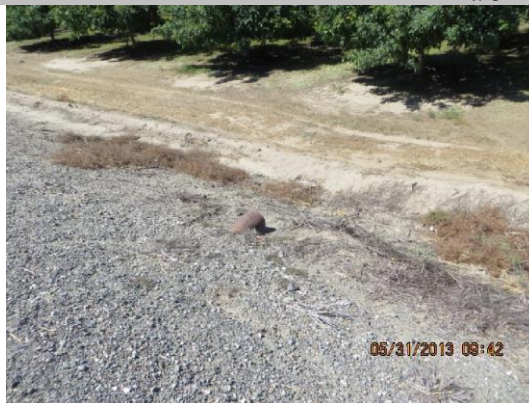
Photo 1 of 3 : UCIP_SP_2019_53341_23668.jpg

Comment Code					
Inspector Comment					
FS_ID:53341 DS_ID:22918 EP_NO: 9563 Repair Type: Non-Urgent Crossing Status: Found UCIP Comments: 10/9/2018 Pipe is open on both ends and damaged on WS. Recommended grouting in place. Crossing downgraded to "Non-Urgent" due to pipe location above floodplain. (O.Yakimov - DWR)12/21/2016 same as last inspection crossing is opened on both ends and damaged on WS slope is visible. According to LMA representative, Nick Henning, pipe appears to be abandoned. (O. Magana - DWR UCIP)05/31/2013 Pipe open on both ends and damaged on WS slope. Pipe should be abandoned properly if appropriate. (W. Wylie - DWR UCIP) FIELD_STRUCT_DESC: *ABANDONED* 12-inch steel drainage pipe through levee, 5 feet below crown. Pipe open on both waterside (WS) and landside (LS) ends. One corrugated metal cutoff wall. (12-inch pipe [HLM 8.6] authorized under Automatic Board Order (ABO) No. 9563, 1974 - County of Glenn). [Additional Reference(s): DWR Levee Log, 1992. USACE Sacramento O&M Manual Unit 140, May 1960, (HLM 8.60)]. FS Date: 10/9/2018 3:57:00 PM

Pipe on LS slope.

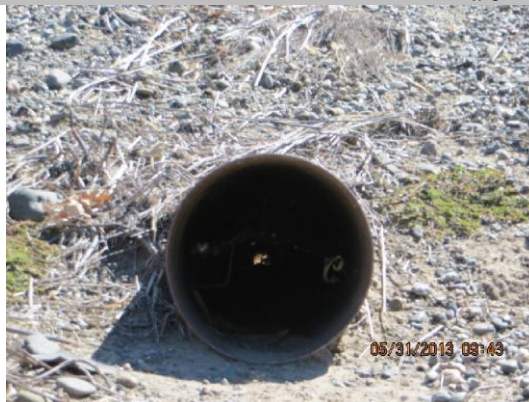
Photo 2 of 3 : UCIP_SP_2019_53341_23667.jpg

Pipe on LS slope.

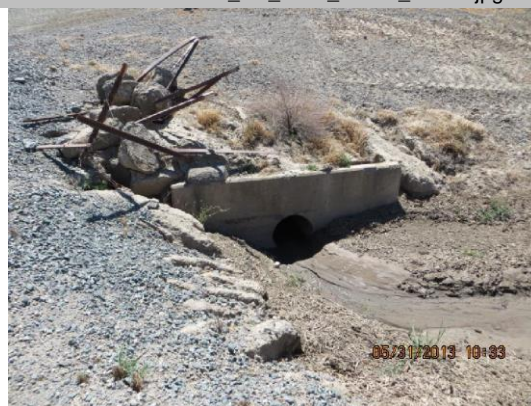
Photo 2 of 3 : UCIP_SP_2019_14390_23689.jpg

Concrete headwall and pipe at LS toe.

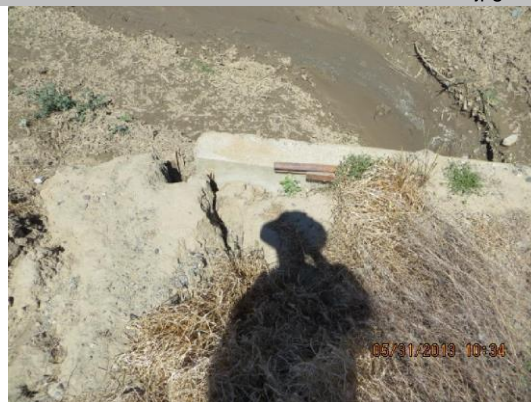
Photo 3 of 3 : UCIP_SP_2019_14390_23688.jpg

Erosion around headwall at LS toe.

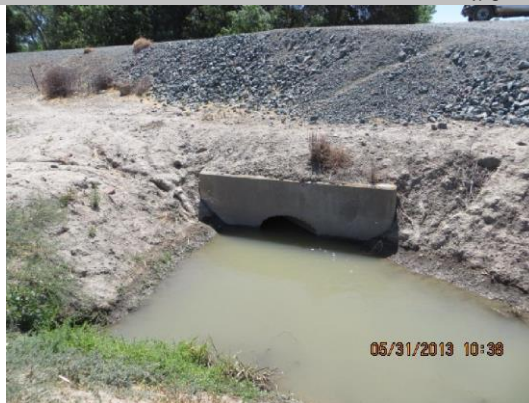
Photo 1 of 3 : UCIP_SP_2019_14559_23986.jpg

Pipe and headwall on LS toe.

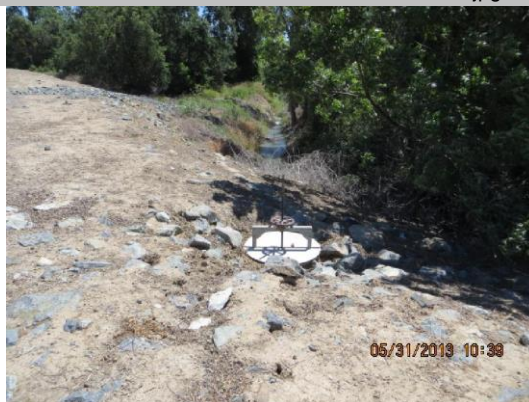
Photo 2 of 3 : UCIP_SP_2019_14559_23985.jpg

Slide gate in 36-inch CMP riser on WS slope.

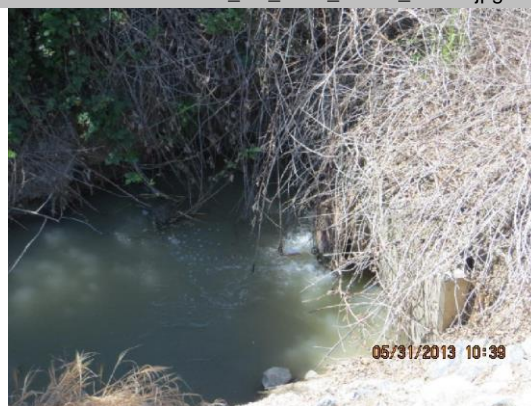
Photo 3 of 3 : UCIP_SP_2019_14559_23984.jpg

Pipe, flapgate, and headwall on WS toe.

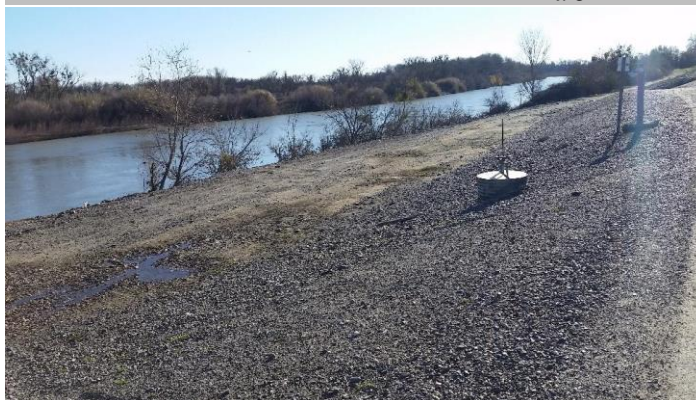
Photo 1 of 3 : UCIP_SP_2019_53340_76411.jpg

UCIP Comments: 10/9/2018 Large rock at the bottom of CMP riser obstructs slide gate from completely closing. Pipe is rusted through at WS end. Recommend internal inspection to determine condition of pipe through levee, and to clean the inside of CMP riser for proper slide gate function. (O.Yakimov - DWR)12/21/2016 same as last inspection flap gate disabled in open position. Surface erosion observed on LS slope. Recommend repair on WS flap gate to be able to close flap gate. (O. Magana - DWR UCIP)05/31/2013 Flap gate dissabled in open position. Pipe rusted through at WS toe upstream of Flapgate. (W. Wylie - DWR UCIP)

View of WS.

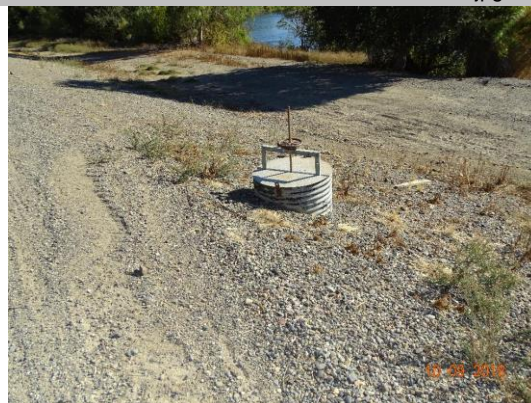
Photo 2 of 3 : UCIP_SP_2019_53340_78135.jpg

Water-Side

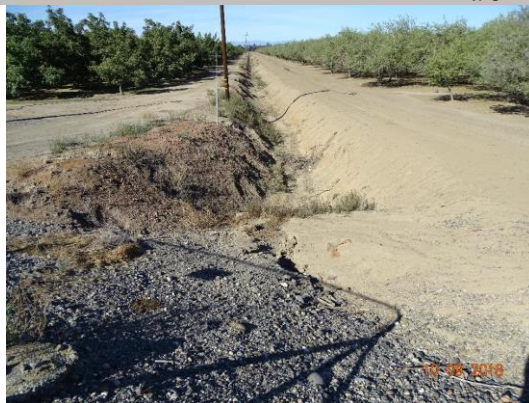
Photo 3 of 3 : UCIP_SP_2019_53340_78136.jpg

Drainage channel on LS.

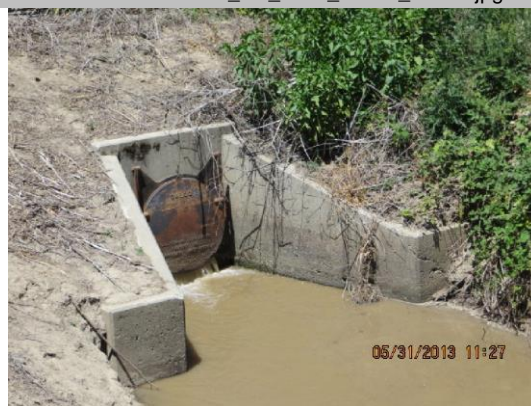
Photo 3 of 3 : UCIP_SP_2019_14565_24007.jpg

Flap gate and concrete headwall on WS toe.

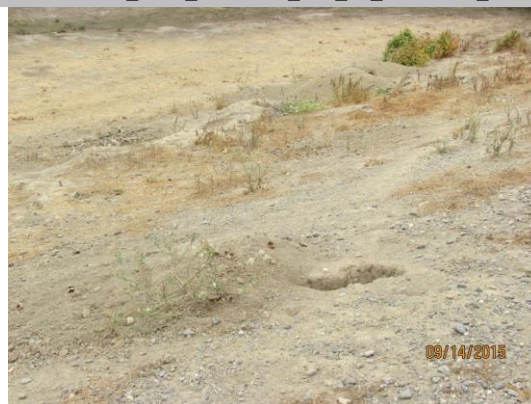
Photo 1 of 1 : SP_2019_LD0001G_432_66_20190313_00024.jpg

LM Start	11.10	Rating **	M	Issue No.	66
LM End	11.18	Issue Type +	Ma	Location *	WS
Category	Earthen Levee			GPS Latitude/Longitude	
				Start	End
Item	Animal Control			39.617252 °	39.618192 °
				-121.994605 °	-121.995609 °
DWR ID	DWR_LD0001G_01_f _ 2015_66				
Comment Code					
A3 : No rodents visible, but rodent burrows visible; need to backfill and compact or grout burrows.					
Inspector Comment

View of the rodent holes along the waterside slope.

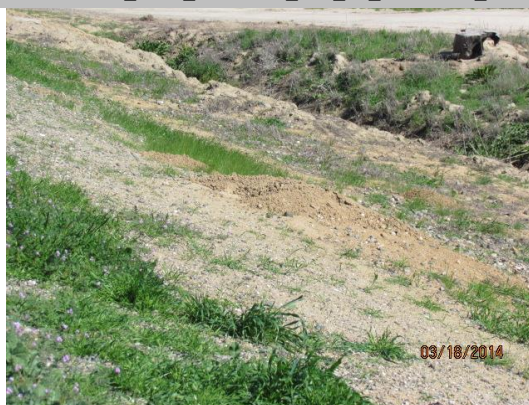
Photo 1 of 1 : SP_2019_LD0001G_432_48_20190313_00015.jpg

View of the rodent activity along the waterside slope.

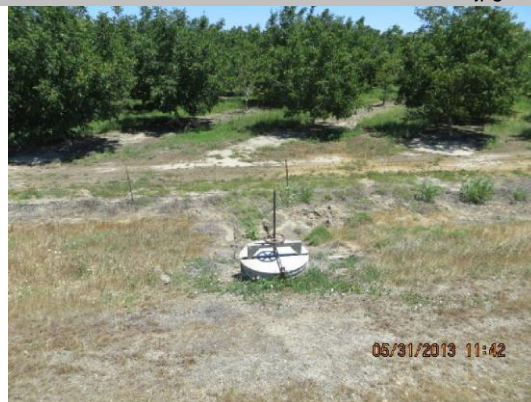
Photo 2 of 3 : UCIP_SP_2019_14566_24012.jpg

Slide gate in 36-inch CMP riser on WS slope.

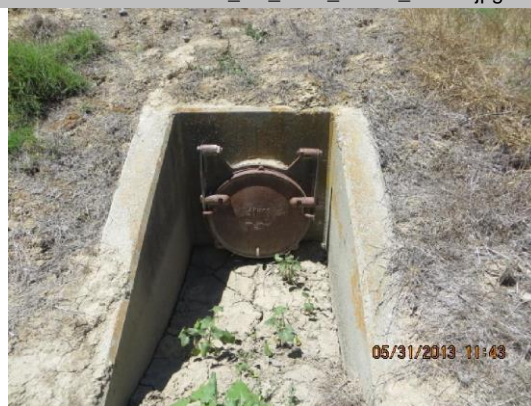
Photo 3 of 3 : UCIP_SP_2019_14566_24011.jpg

Concrete headwall and flapgate on WS toe

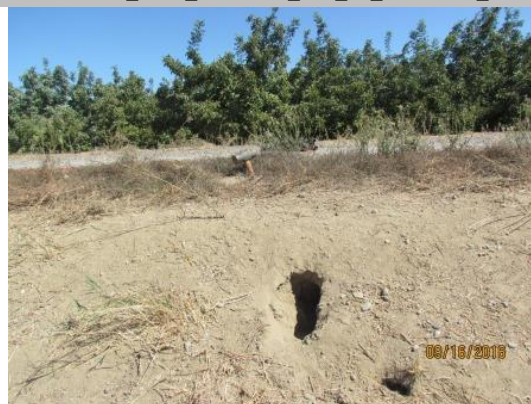
Photo 1 of 2 : SP_2019_LD0001G_432_79_20190313_00033.jpg

LM Start	11.66	Rating **	U	Issue No.	79
LM End	11.66	Issue Type +	Ma	Location *	LS
Category	Earthen Levee			GPS Latitude/Longitude	
				Start	End
Item	Animal Control			39.624112 °	39.624112 °
				-121.999933 °	-121.999933 °
DWR ID	DWR_LD0001G_01_f_2016_79				
Comment Code					
A3 : No rodents visible, but rodent burrows visible; need to backfill and compact or grout burrows.					
Inspector Comment					
Rodent holes are present on the landside slope and crown.

View of the rodent holes along the landside slope with large hammer sitting in the hole.

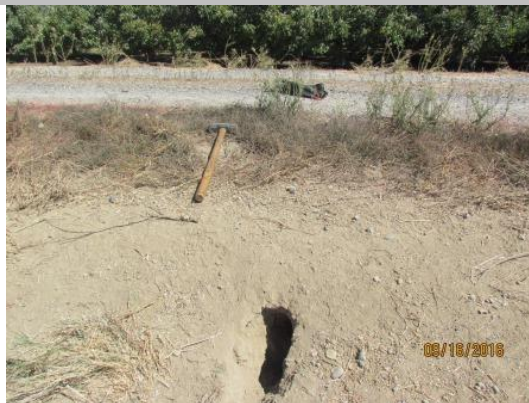
Photo 2 of 2 : SP_2019_LD0001G_432_79_20190313_00034.jpg

Another view of the rodent holes along the landside slope with a large hammer sitting next to the hole.

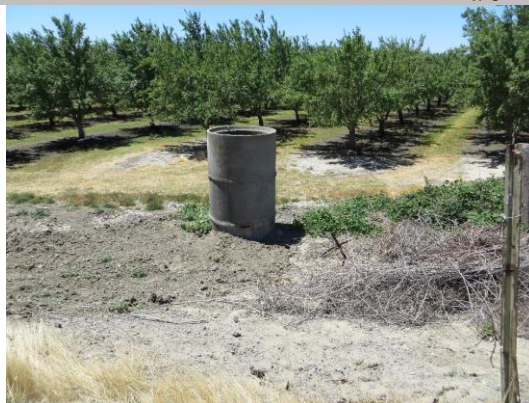
Photo 1 of 3 : UCIP_SP_2019_14567_24017.jpg

Comment Code					
Inspector Comment					
FS_ID:14567 DS_ID:22927 EP_NO: 9554 Repair Type: Non-Urgent Crossing Status: Found UCIP Comments: Erosion and sloughing on LS slope possibly due to rodent activity in area. FIELD_STRUCT_DESC: 24-inch corrugated metal drainage pipe through the levee, 11 feet below the crown. Slide gate in 36-inch corrugated metal riser unit on the waterside (WS) slope. 48-inch concrete standpipe on the landside (LS) toe. Two corrugated metal cutoff walls. (24-inch pipe [HLM 11.93] authorized under Automatic Board Order (ABO) issued as Permit No. 9554, 1974 - Thomas H. Reed). [Additional Reference(s): DWR Levee Log, 1992. USACE Sacramento O&M Manual 140, May 1960, (HLM 11.93)]. FS Date: 5/31/2013

Concrete standpipe on LS toe.

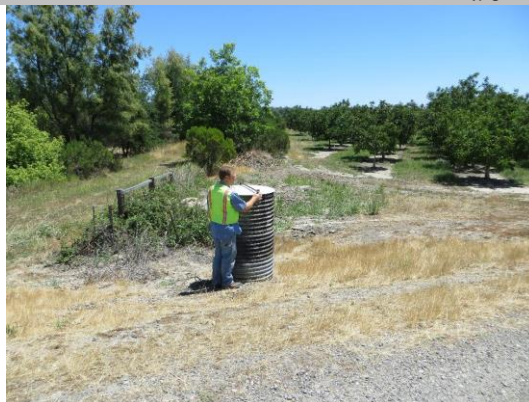
Photo 2 of 3 : UCIP_SP_2019_14567_24016.jpg

Slide gate in CMP riser on WS toe.

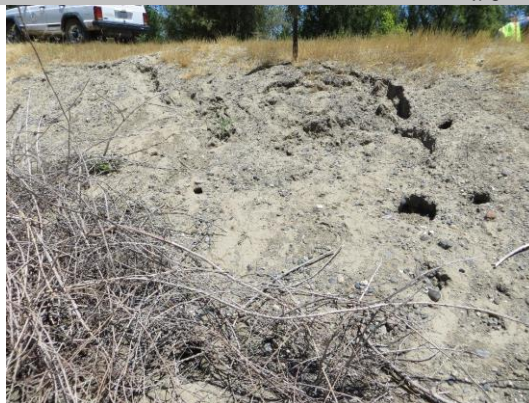
Photo 3 of 3 : UCIP_SP_2019_14567_24015.jpg

Erosion and sloughing on LS slope possibly due to rodent activity.

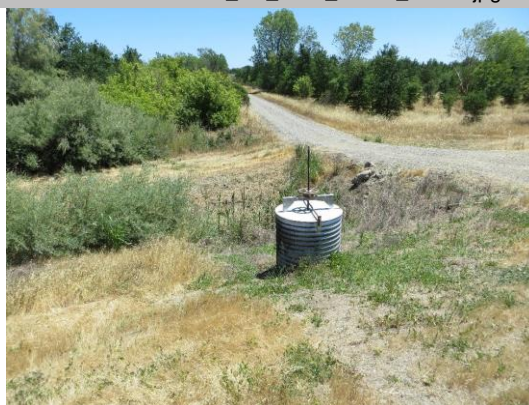
Photo 1 of 3 : UCIP_SP_2019_14569_24026.jpg

Comment Code					
Inspector Comment					
FS_ID:14569 DS_ID:22928 EP_NO: 9554 Repair Type: Non-Urgent Crossing Status: Found UCIP Comments: Flap gate heavily corroded. Good candidate for video inspection. Vegetation interfering with inlet. FIELD_STRUCT_DESC: 24-inch corrugated metal drainage pipe through the levee, 7 feet below the crown. Flap gate on the waterside (WS) end. Slide gate in 36-inch corrugated metal pipe riser unit on the WS slope. Concrete headwalls on both ends. Two corrugated metal cutoff walls. (24-inch pipe [12.04] authorized under Automatic Board Order (ABO) issued as Permit No. 9554, 1974 - Thomas H. Reed). [Additional Reference(s): DWR Levee Log, 1992. USACE Sacramento O&M Manual 140, May 1960, (HLM 12.04)]. FS Date: 5/31/2013

Slidegate in 36-inch CMP riser on WS slope.

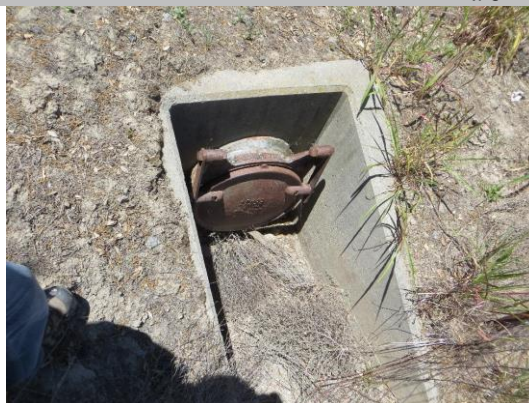
Photo 1 of 3 : UCIP_SP_2019_14570_24029.jpg

Flapgate and U-shaped concrete headwall on WS toe.

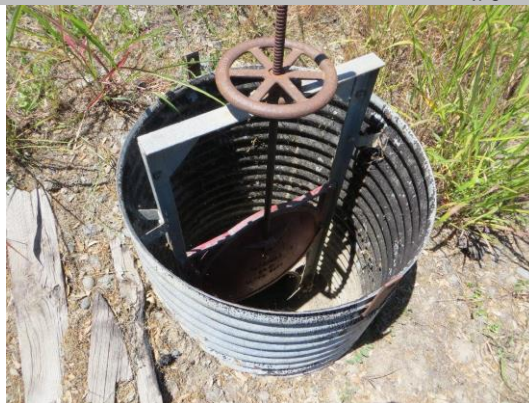
Photo 2 of 3 : UCIP_SP_2019_14570_24028.jpg

Slidegate in 36-inch CMP riser on WS slope.

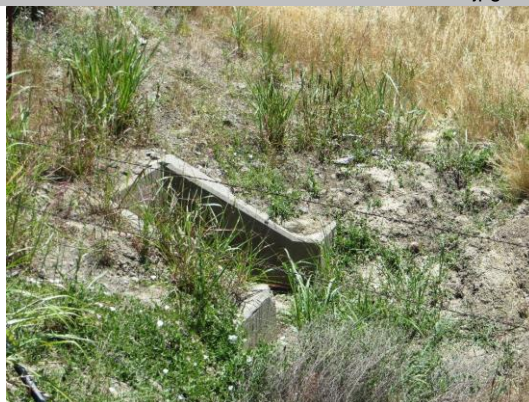
Photo 3 of 3 : UCIP_SP_2019_14570_24027.jpg

U-shaped concrete headwall on LS toe.
